# Parametric analysis of groundshock loading on steel plates and reinforced concrete slabs

Thesis submitted to the University of Sheffield  
for the degree of Doctor of Philosophy

**University of Sheffield**  
**Department of Civil and Structural**  
**Engineering**

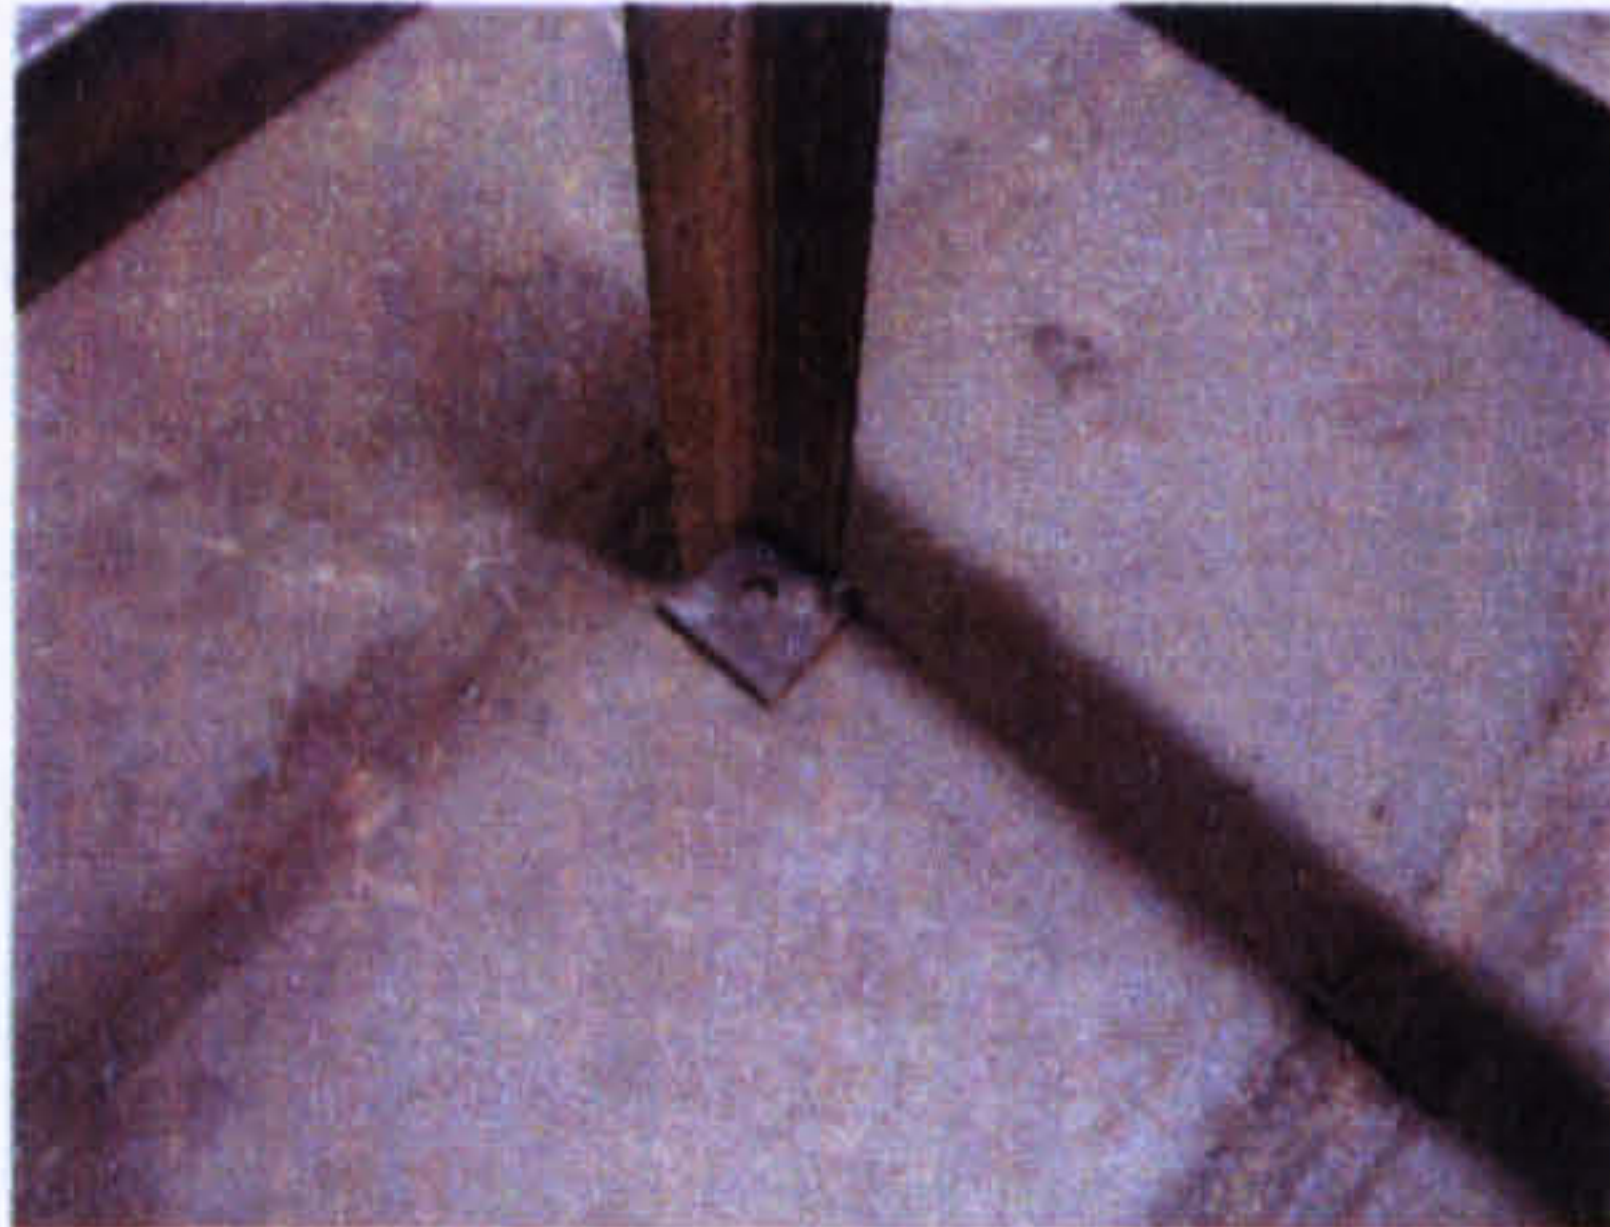
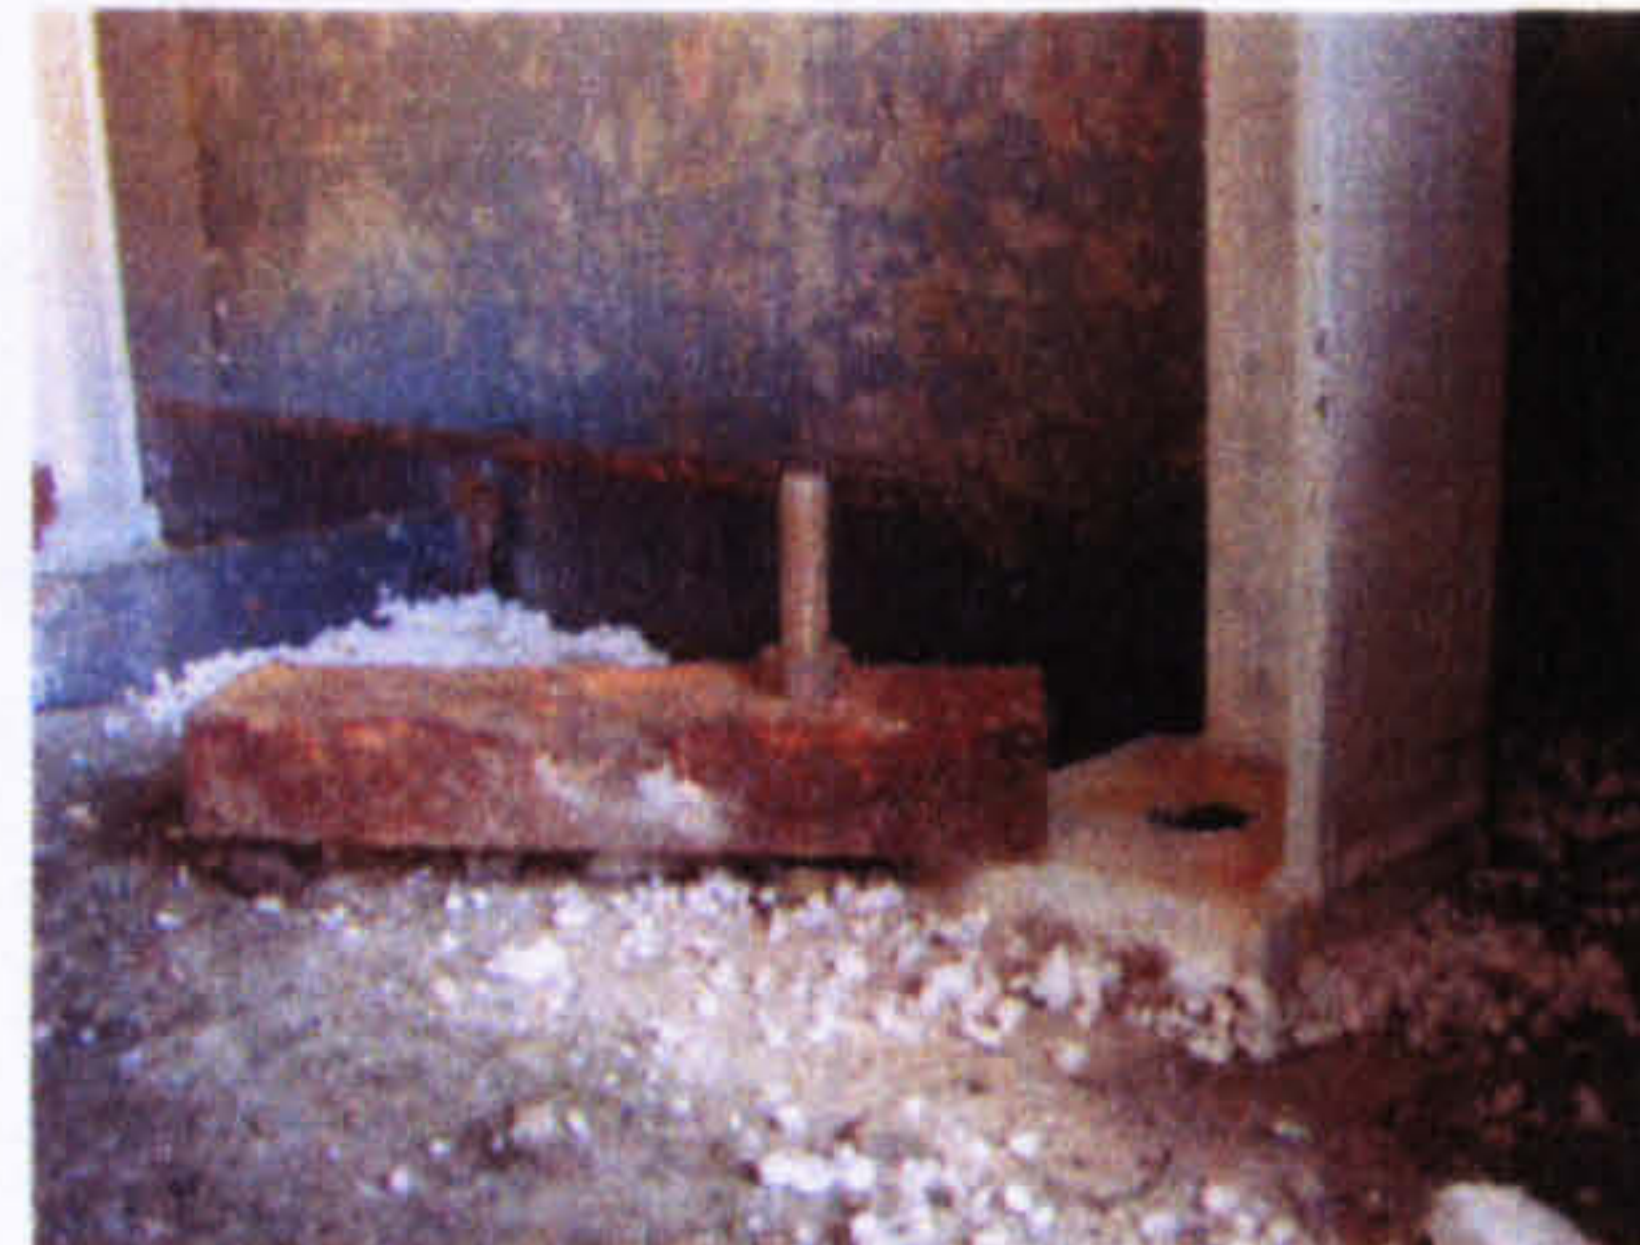
**Plate 3.2.3 Securing the legs of the support structure to the ground**

The top frame section consisted of four welded angle sections of size 80x80x12mm and four leg sections of size 80x80x10mm. The legs were positioned on welded base plates, individually clamped into the ground, by a lever-arm clamping system, as illustrated in plate 3.2.3. This secured the structure to the ground during the explosive tests.

Base plate

Clamping system

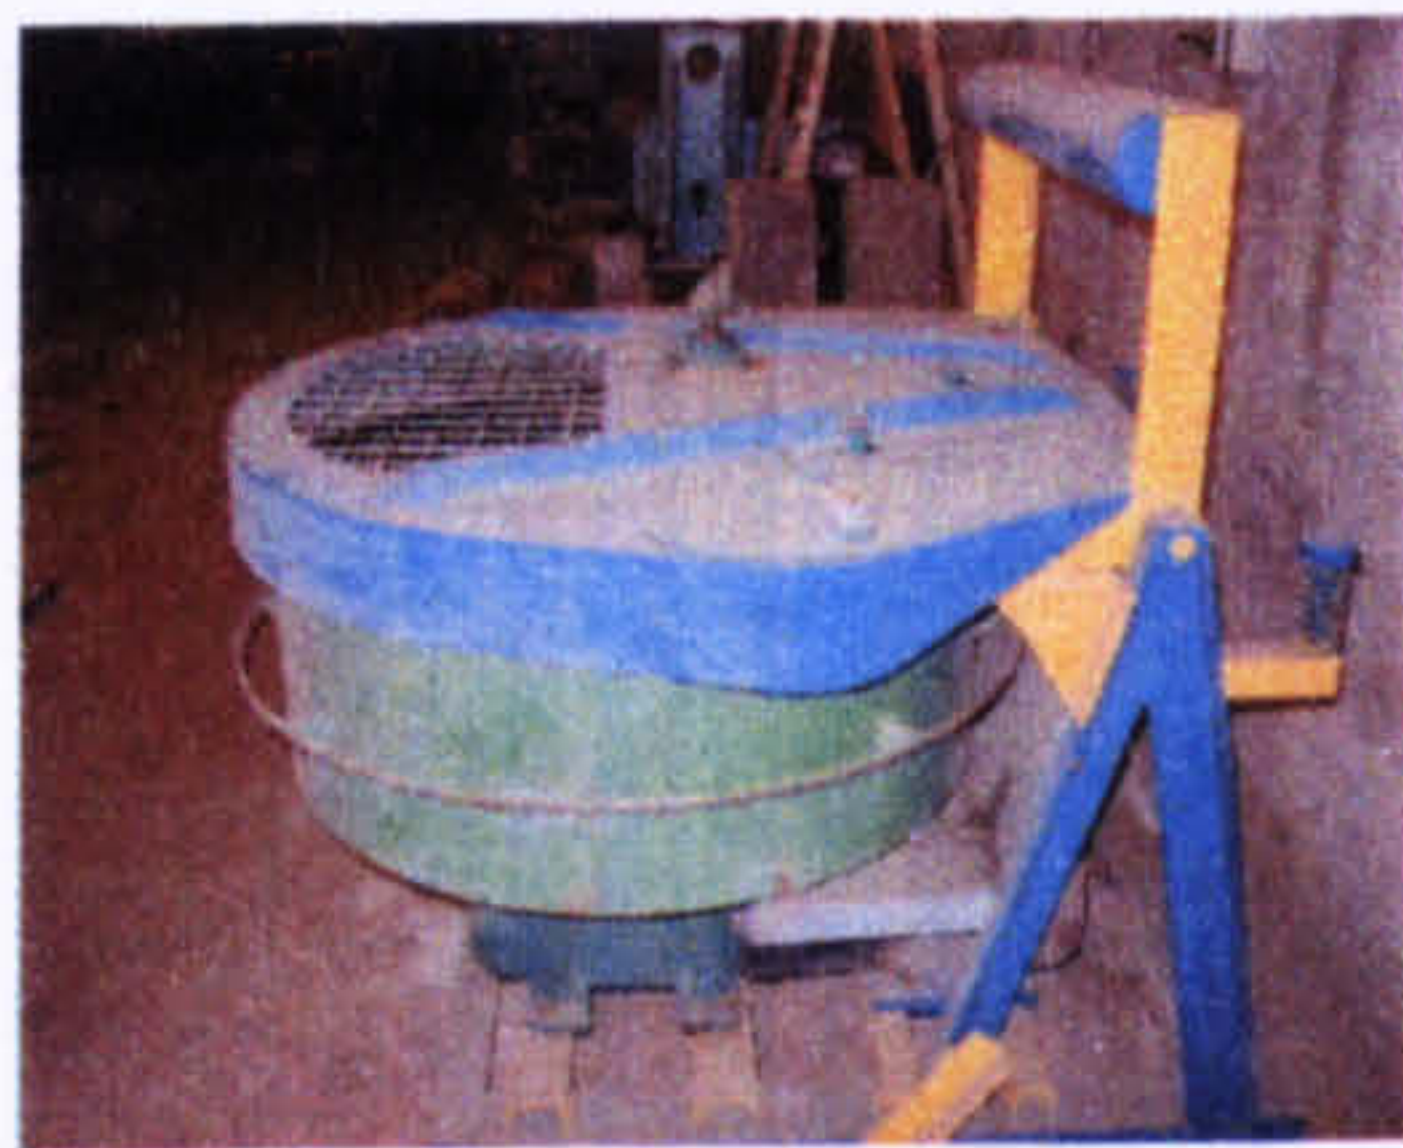
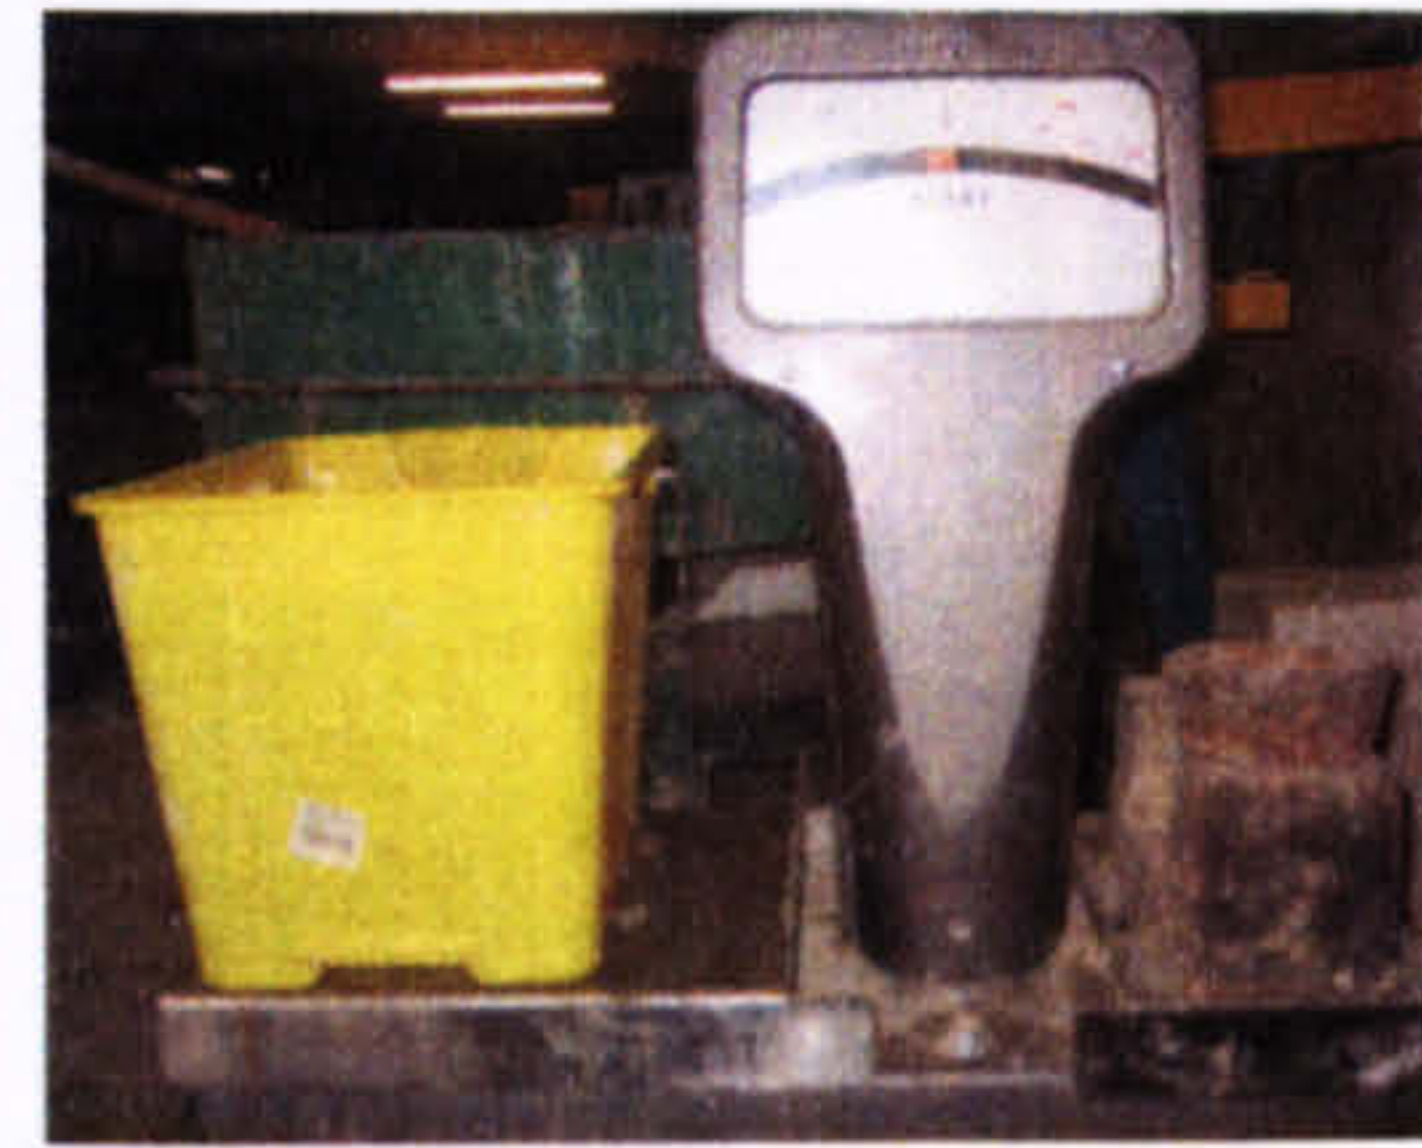
**Plate 3.4.9** Mixing and measuring apparatuses used in casting

The total mass of the slab's constituents was increased by 15% as recommended by **Kong & Evans (1987)** to allow for excess concrete to be made into cubes and cylinders. The apparatuses illustrated in plate 3.4.9 were used to weigh and mix the constituents.

Pan mixer

Water weighing scales

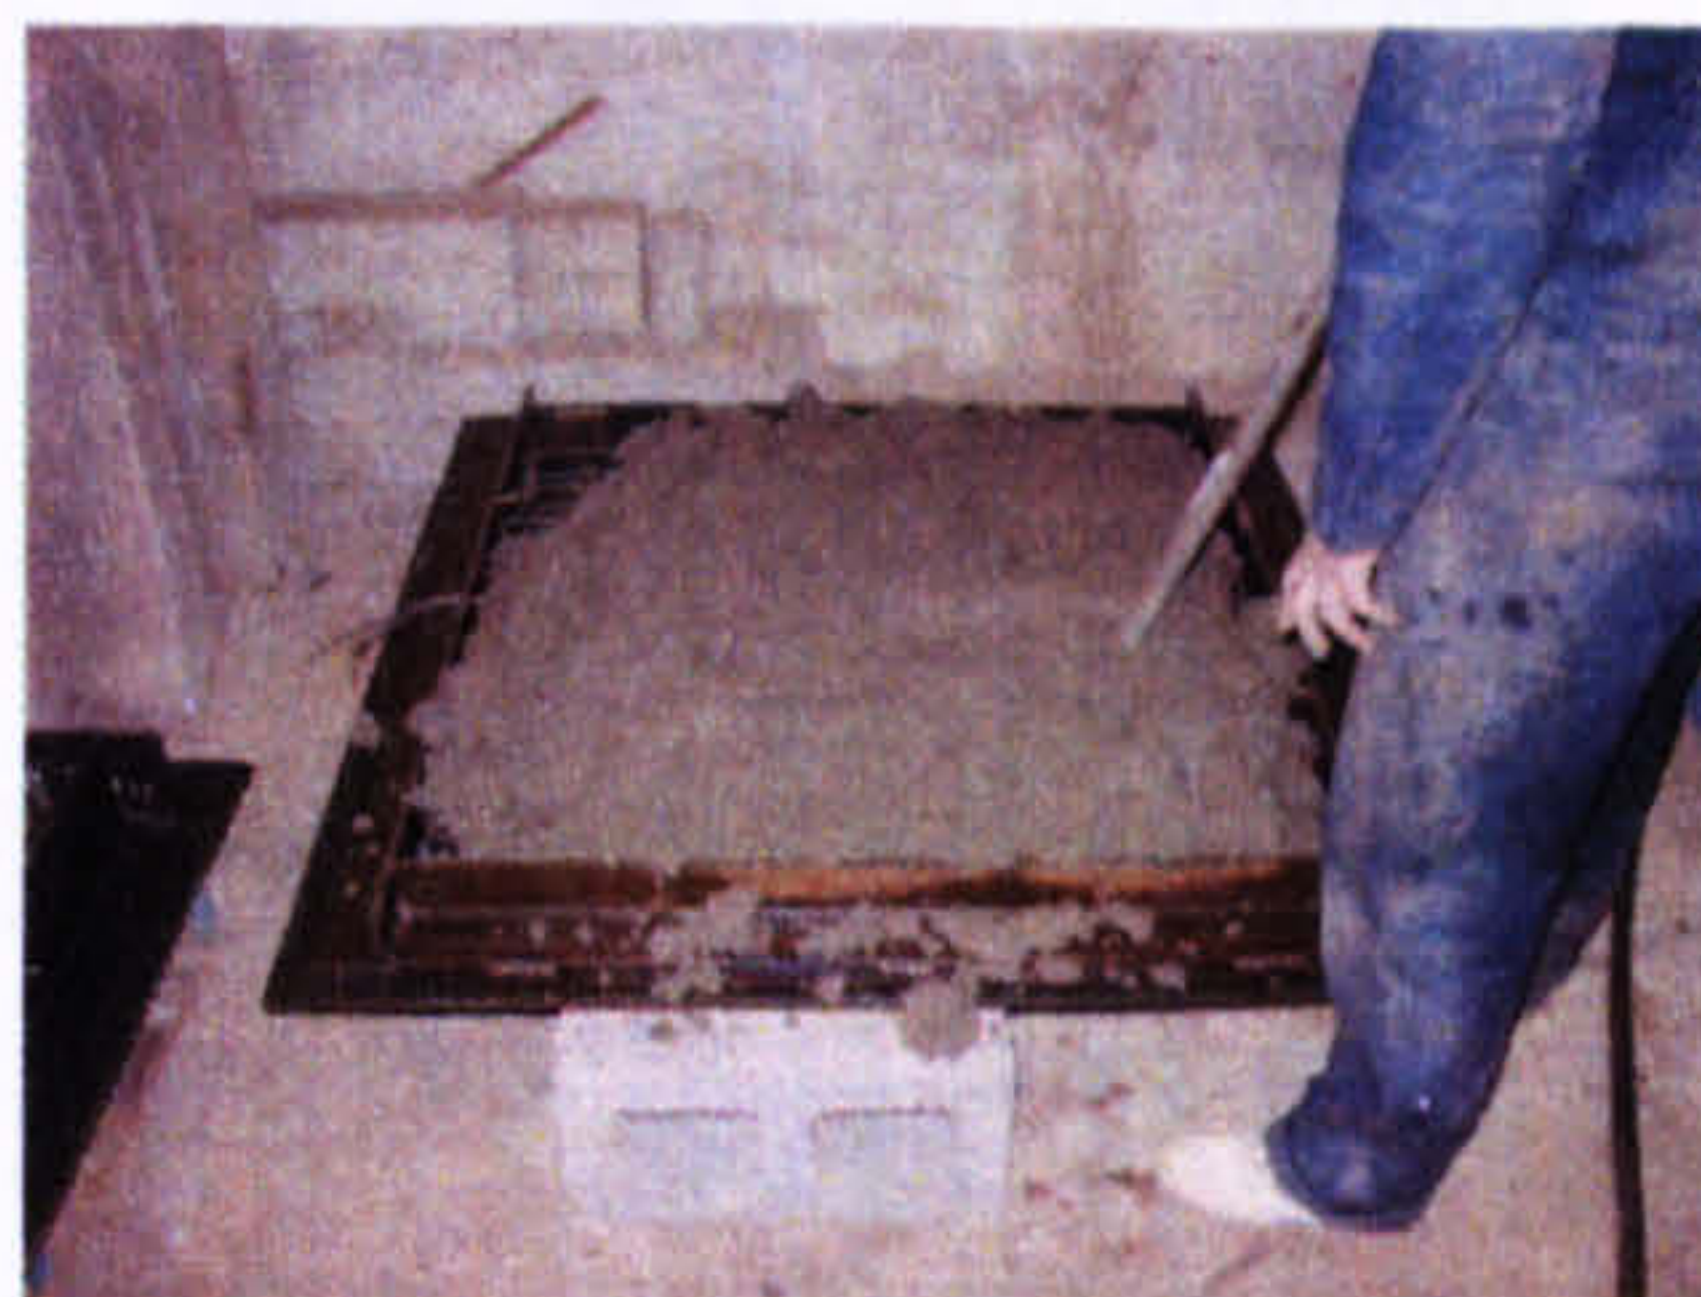
**Plate 3.4.10** Vibrating the concrete

When all the constituents were considered as being fully mixed together, the concrete was cast into the moulds in two layers. Each layer was vibrated with the use of a vibrating poker, as illustrated in plate 3.4.10, until no air bubbles appeared on the concrete surface. Once a mould was filled with concrete that had been vibrated, a surface finish was applied by hand. The slabs, cylinders and cubes were then covered with polystyrene sheets and left for 24 hours, before being checked. During the next six days they were left under damp sacking and polystyrene sheeting in an attempt to prevent dehydration.

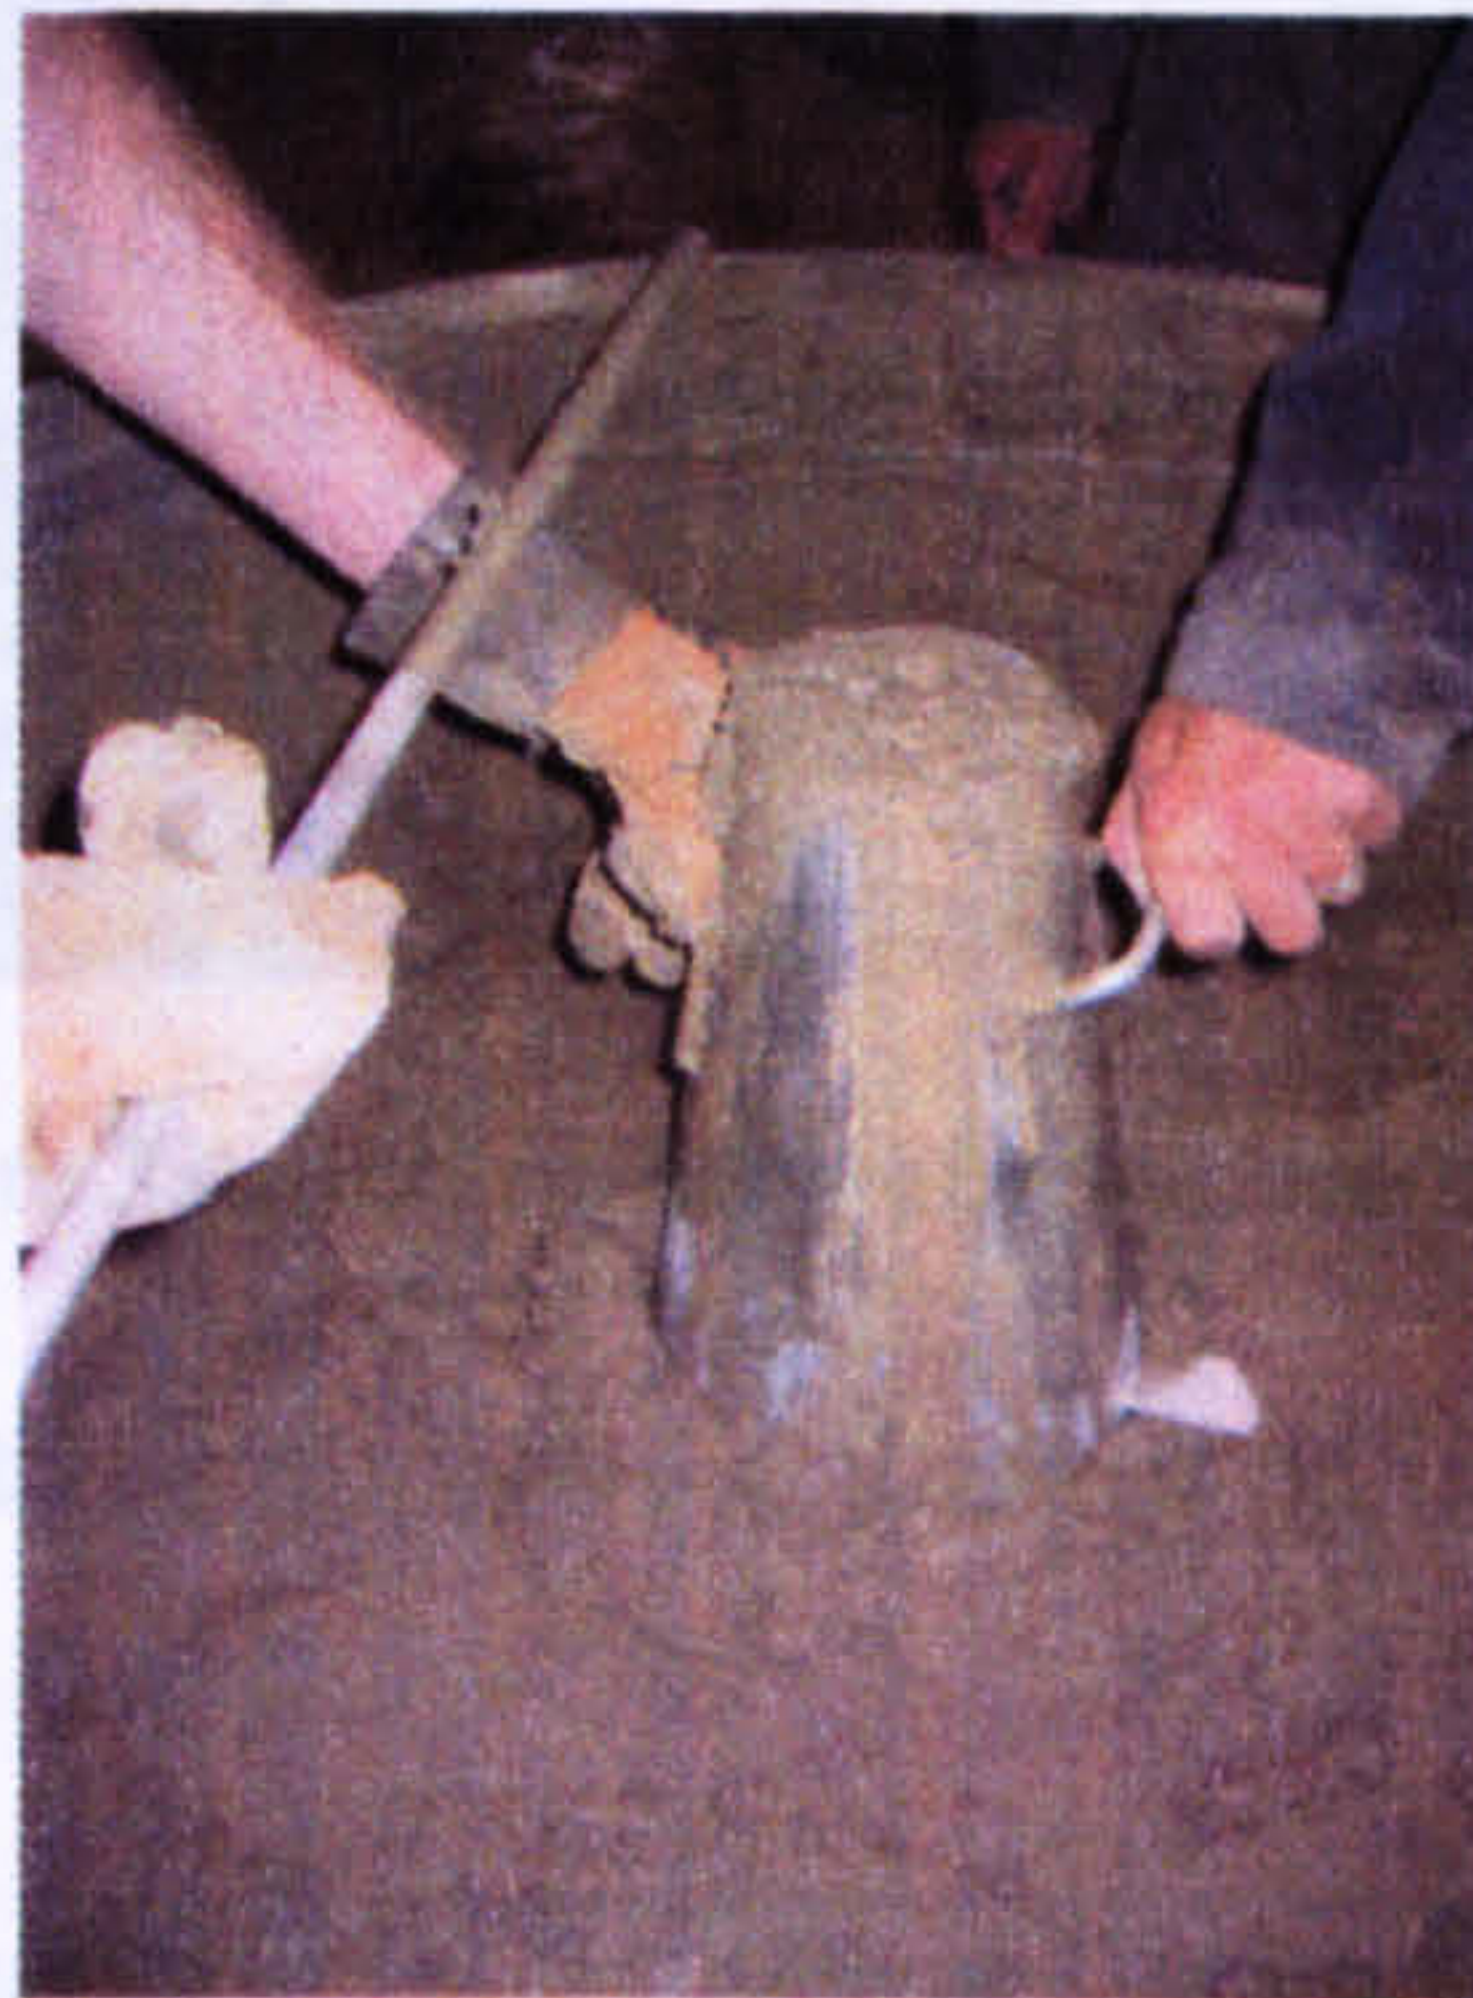
**Plate 3.4.11 Filling a slump device with fresh concrete**

Concrete was poured into the mould in three layers. Each stage occupied a  $\frac{1}{3}$  of the mould's volume. Within each stage, the volume of concrete was rodded 25 times, within its layer. The top surface of the concrete within the mould was then levelled off, leaving a horizontal surface of concrete, ready for the mould removal, as illustrated in plate 3.4.11.

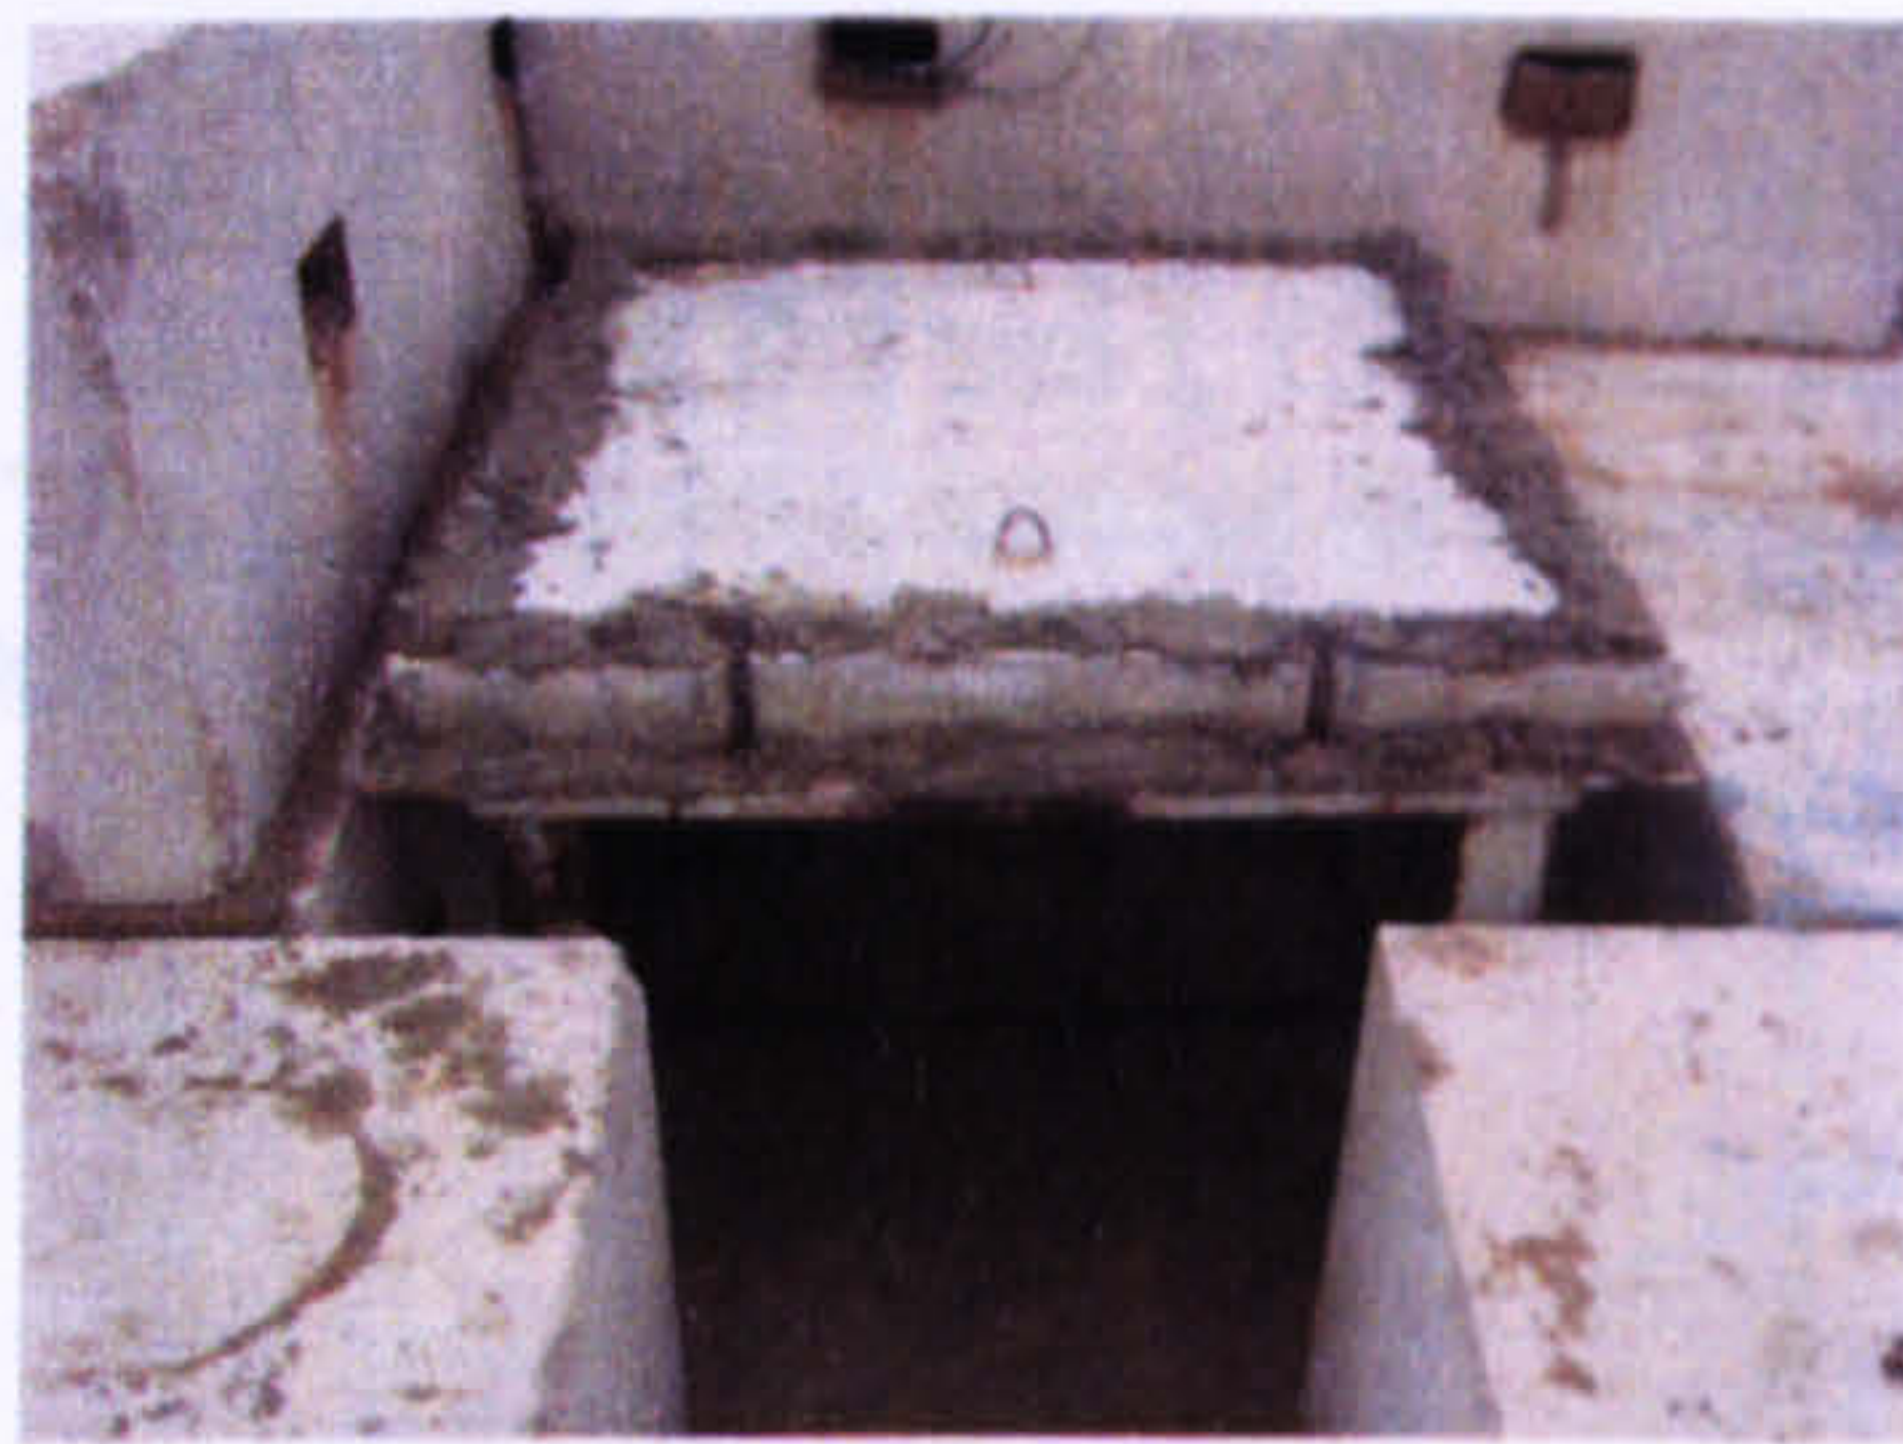
**Plate 3.6.1 Application of the mortar**

A thin layer of mortar was initially applied to the top surface of the steel support frame that formed the bearing support for the primary slab. This compensated for the uneven bottom surface of the slab that was formed during casting. Another layer of mortar was then applied to the top face of the primary slab, as illustrated in plate 3.6.1. This took account of the uneven top surface that was formed during casting and ensured that the clamping system applied a uniform pressure around the perimeter of the slab.

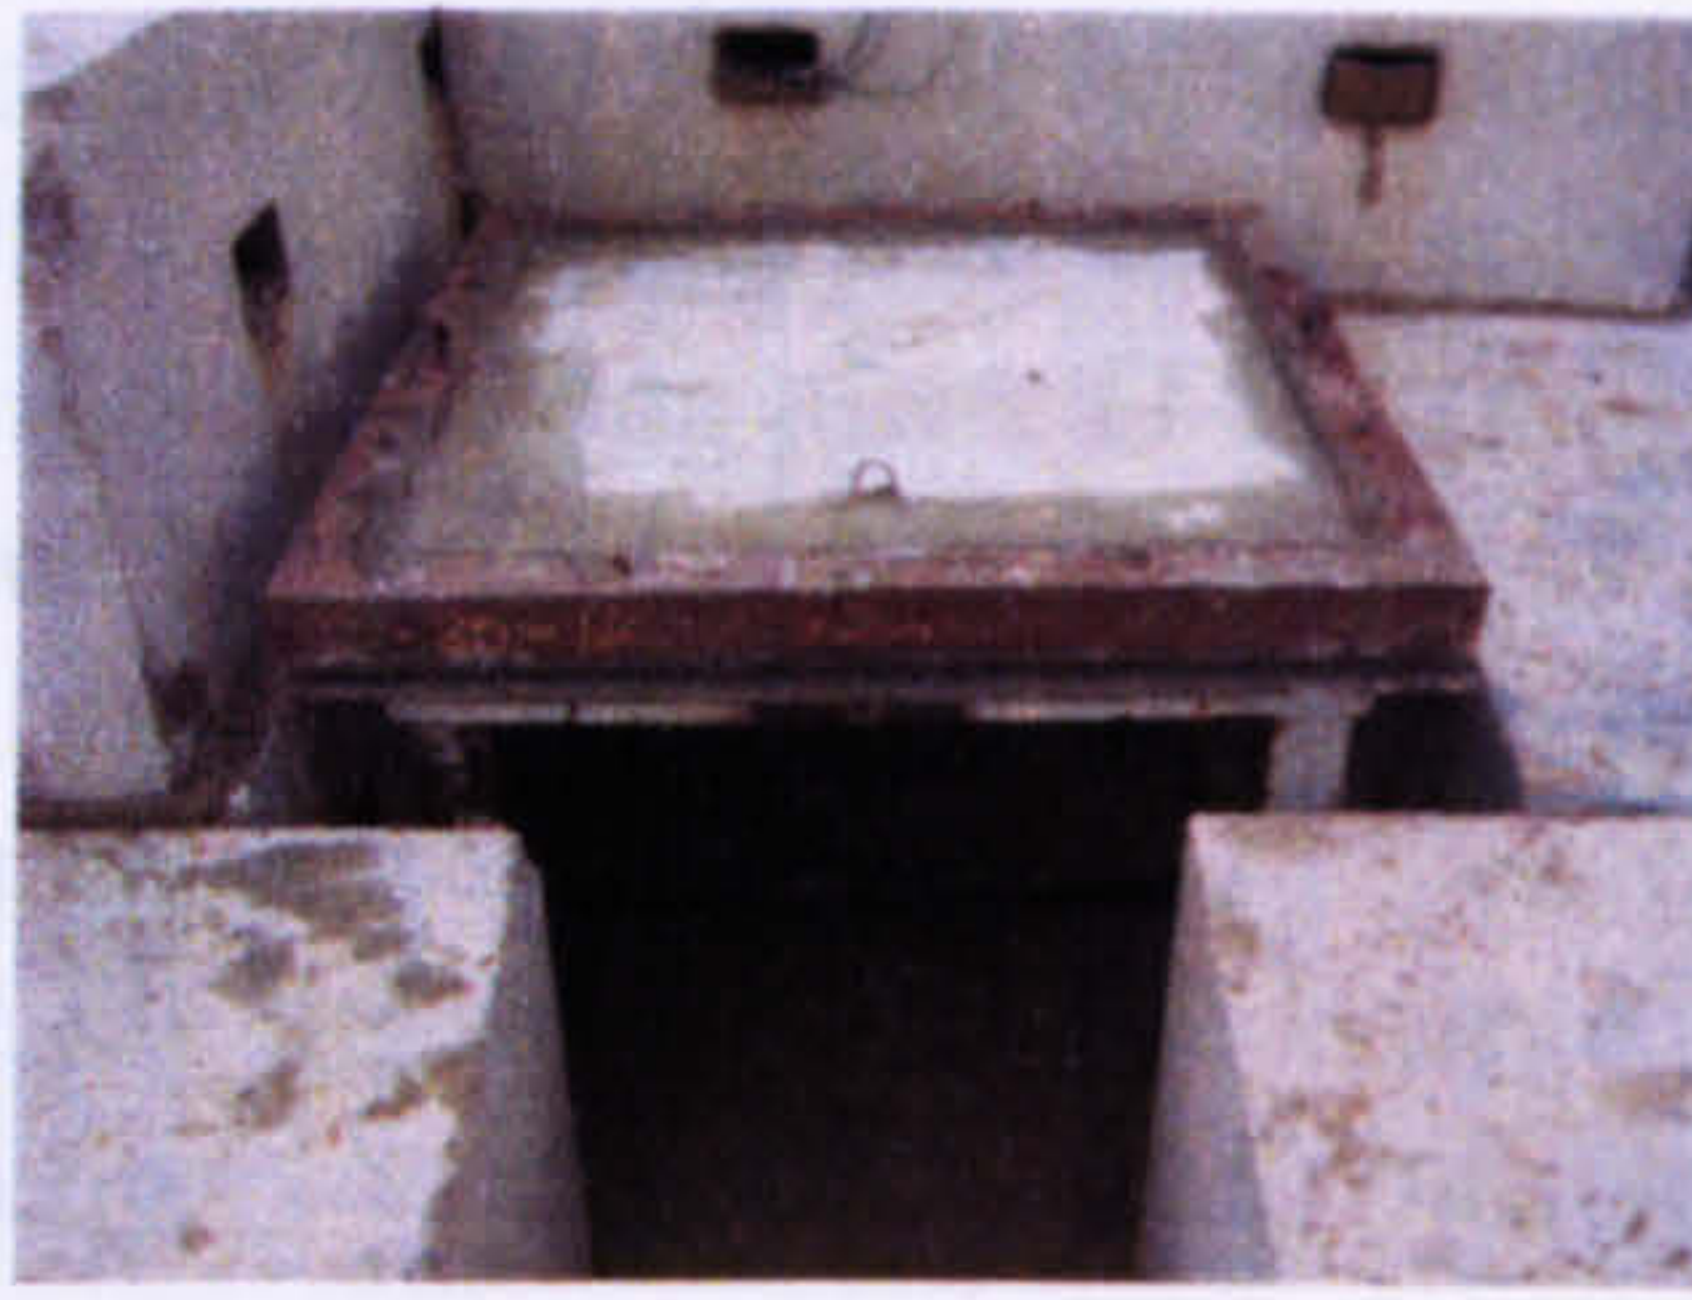
**Plate 3.6.2 Clamping device**

The clamping device constructed from four welded 80x80x12mm angle sections, was then lowered into position, transferring a uniform clamping pressure over the bearing width of the slab, as illustrated in plate 3.6.2.

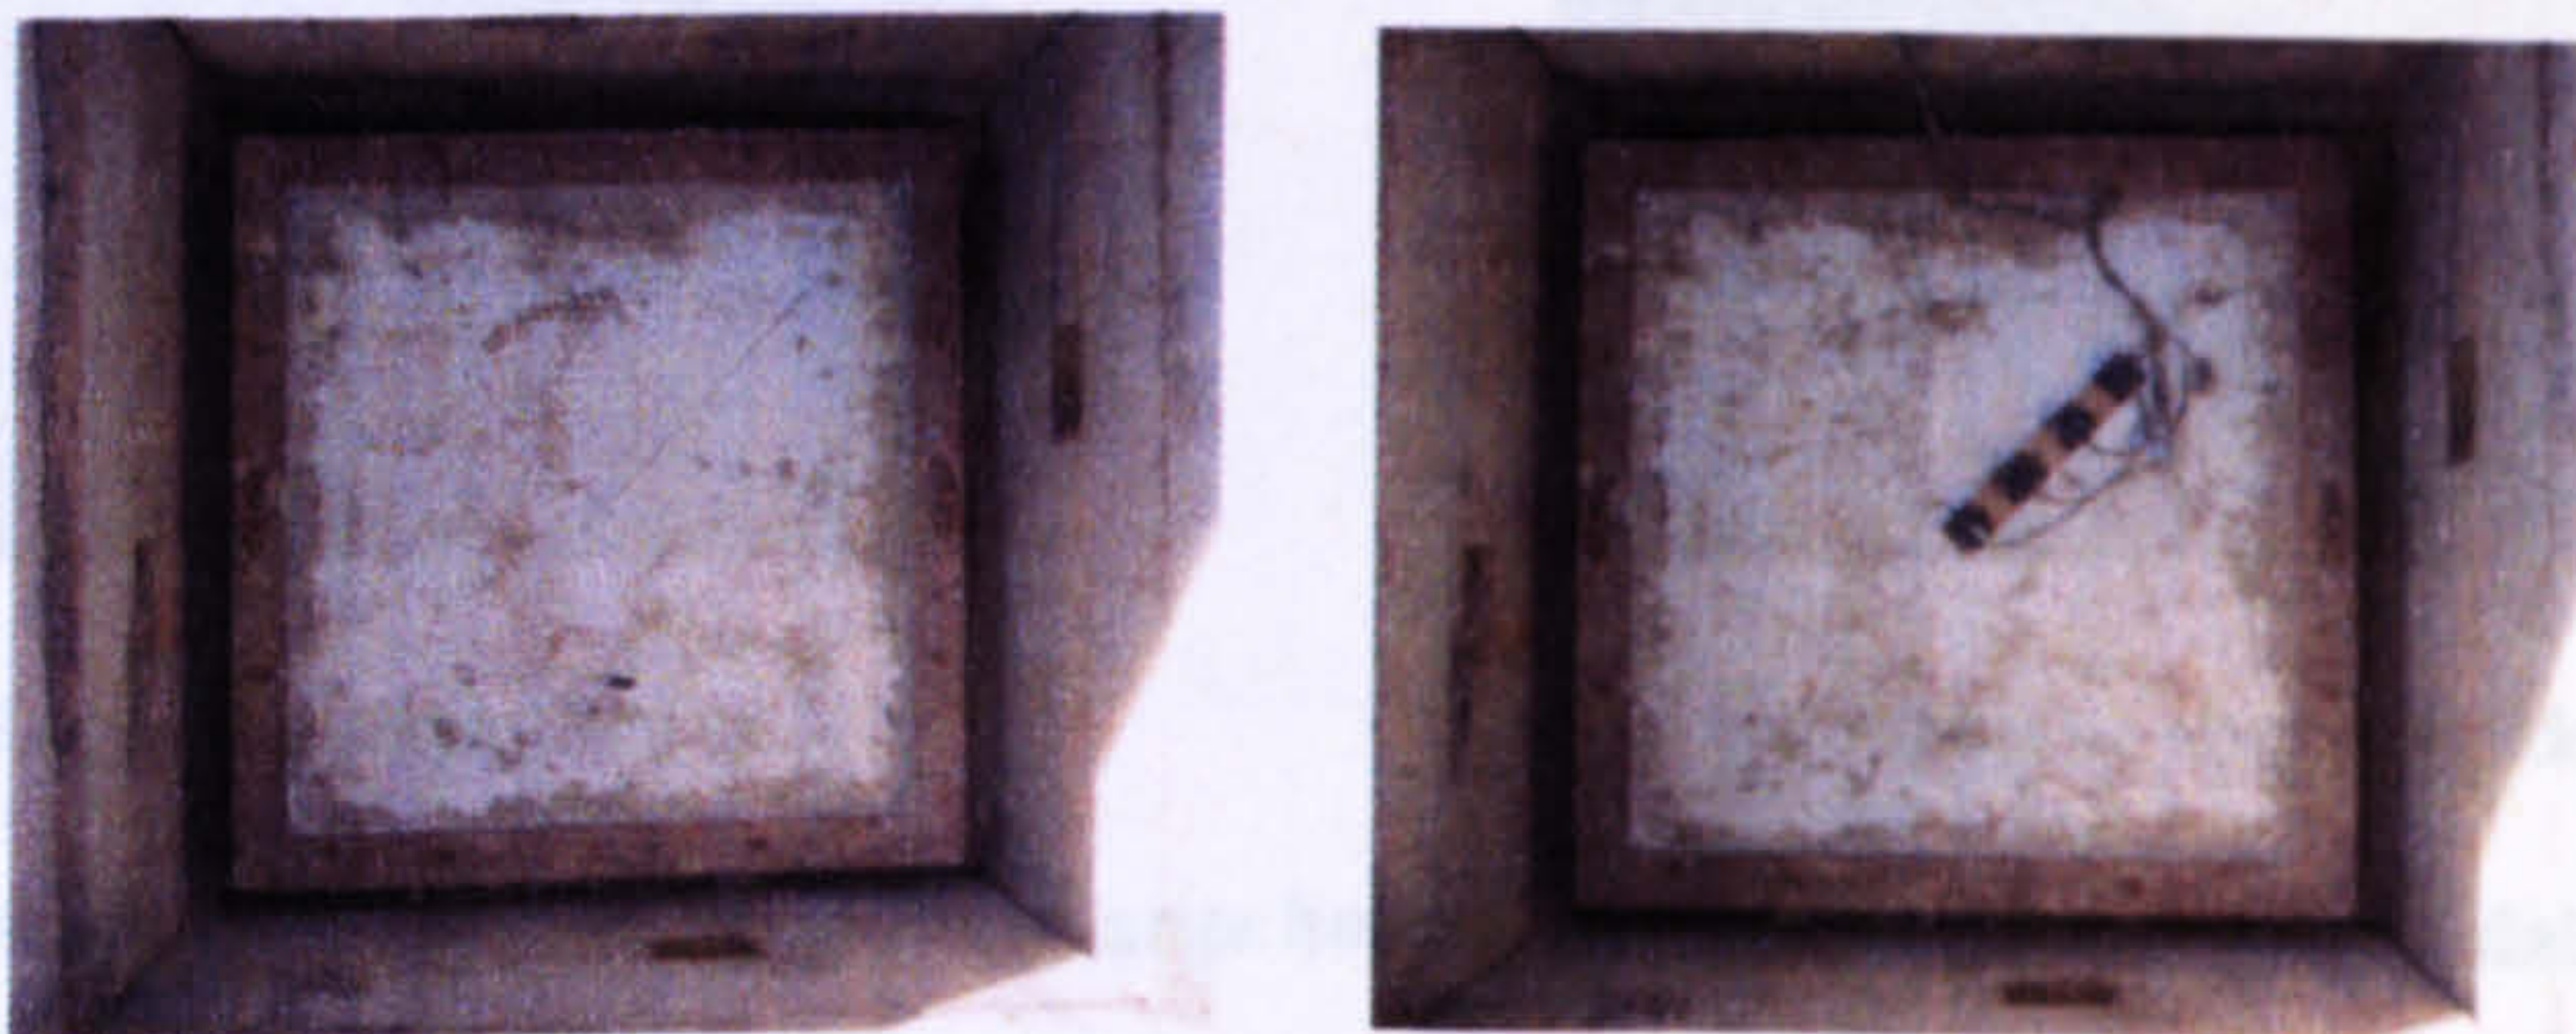
**Plate 3.6.3 Positioning of the DPGs on the top face of the primary slab**

The next step involved positioning the DPGs on the top face of the primary slab as illustrated in plate 3.6.3. The eccentricities of the DPGs relative to the centre of the primary slab varied, depending upon the charge standoff.
